Home Inspection Report
for
John Smith

The Villages at Manu Kai
Kilauea Coast HI 96731
TMK #3-6-0-0-0

Home inspection Summary Report for:
John Smith

Location:
The Villages at Mauna Lani
Kohala Coast HI 96743

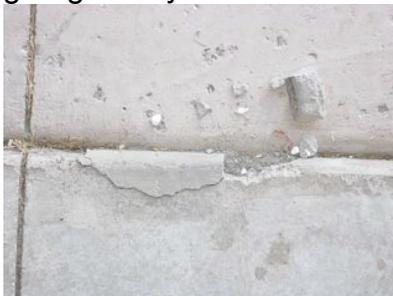
- 1.) I observed a small cosmetically chipped section of concrete slab at the garage entry.

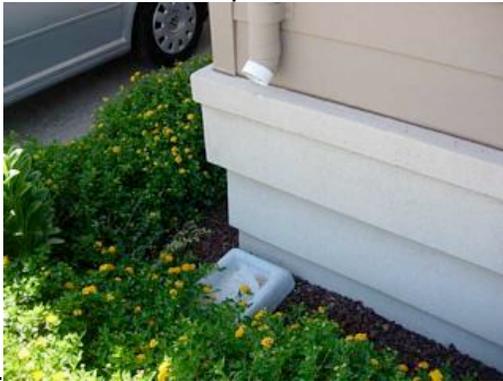
1.) At the gutter downspout between the garage and the entry, a section of gutter downspout is missing. Additionally, at the Northwest corner of the building, the gutter downspout splash block needs to be placed back under the downspout

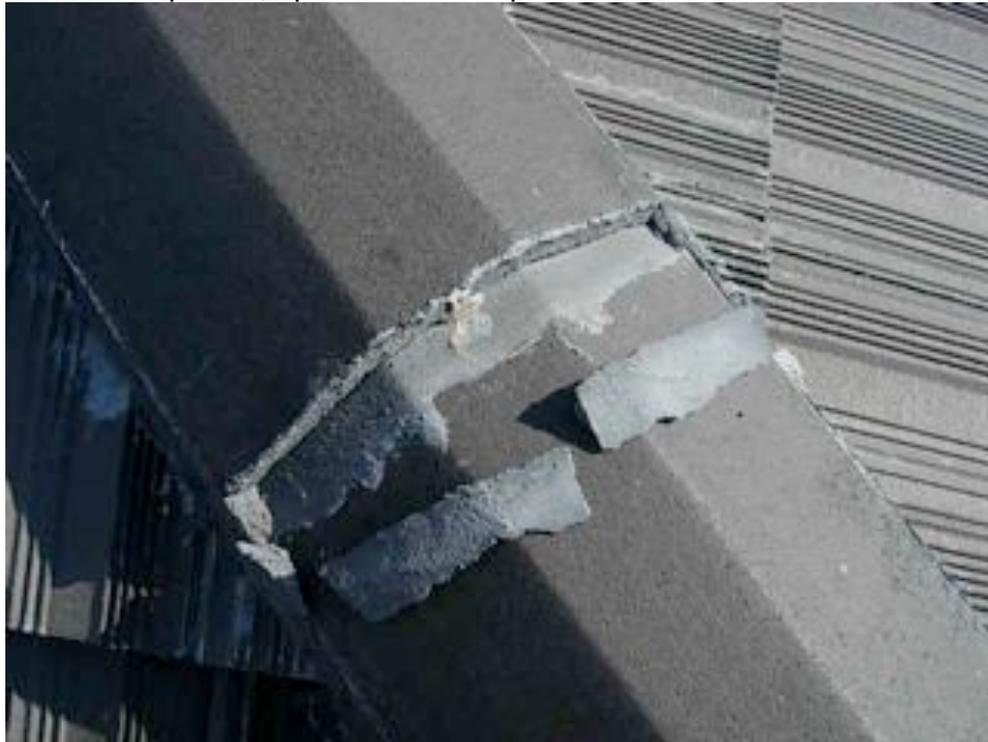
2.) At the roofing I observed a few small sections of ridge and hip cap tile where the tile grout has come loose, apparently as a result of the October 3006 earthquakes, spot cosmetic repair is needed.

A licensed roofing contractor should be consulted to assess and correct the roofing items.

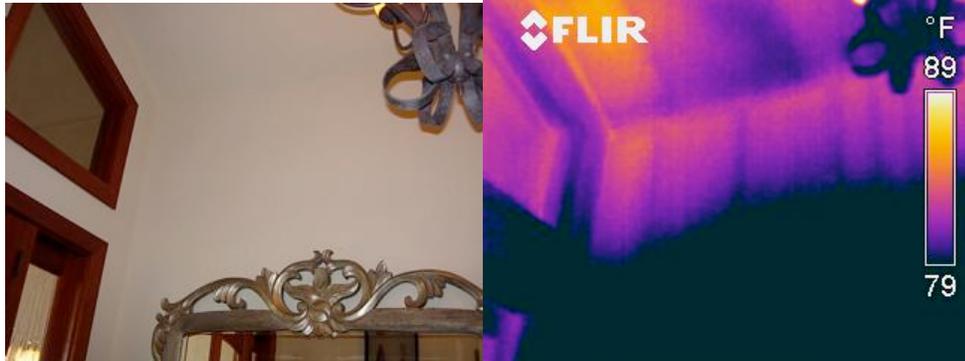
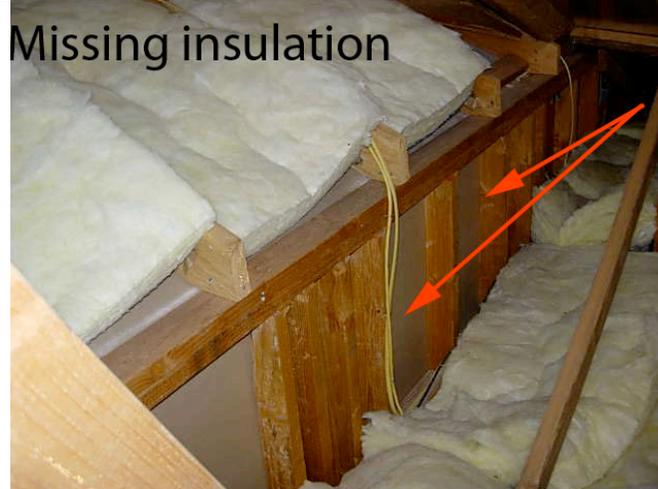
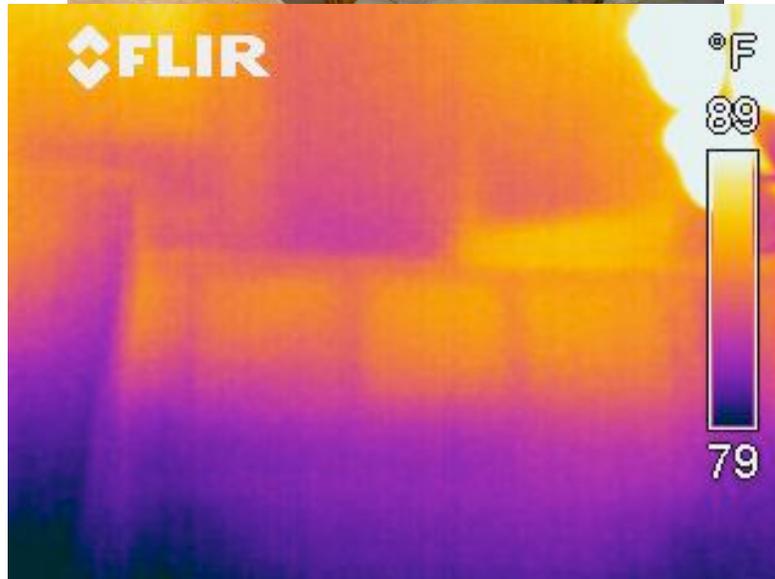
1.) Using the thermal imaging camera, I was able to determine that insulation is missing at the entry foyer vaulted ceiling walls. I was able to confirm this with visual inspection from the attic as well.

The missing or misplaced insulation should be reinstalled by an insulation specialist.

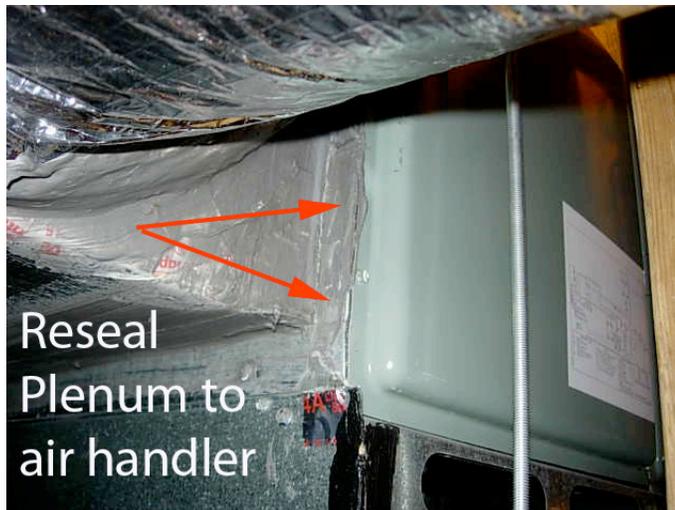
- 1.) The air filters at the return air registers are soiled and will require replacement. Dirty filters significantly reduce the efficiency of these systems. The air filters should be replaced after every 30 to 45 days of continuous system use, and the systems should be serviced annually by a licensed HVAC specialist. Service should include filter changes, coil cleaning, condensate drain line and condensate pan cleaning, and full refrigerant test and balancing services.
- 2.) Additional duct sealant is needed at the supply side of the Southern return air handler. Currently the duct leakage is decreasing system efficiency and causing condensation formation on the air handler exterior around the leak. This is an item that can be simply addressed during routine maintenance.

The area outlined in red in the thermal image is below the dew point, its surface temperature is low enough to cause condensation to form on its surface.

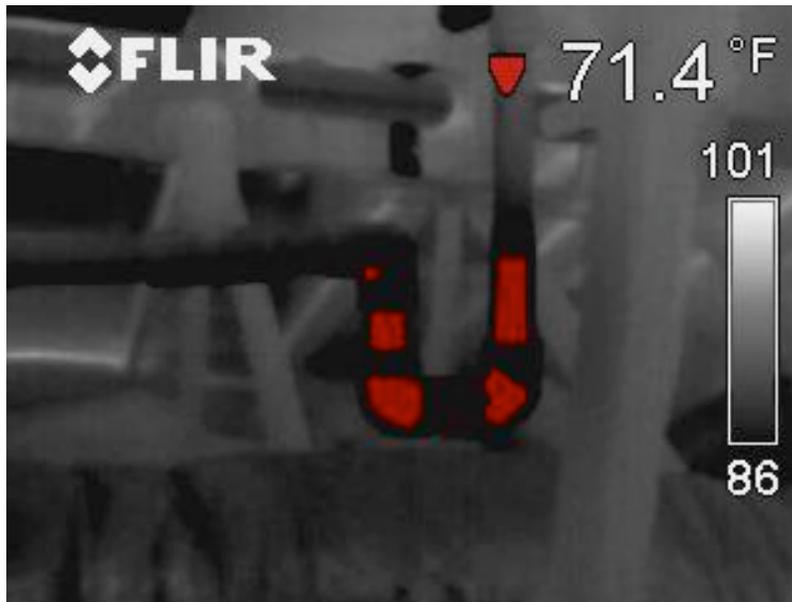
3.) I would recommend insulating the condensate drain lines at both air handlers. After calculating the dew point in the attic space using temperature and relative humidity measurements, I was able to program a dew point alarm into the thermal imaging camera, and determined that the traps at the condensate drain lines cool to below the dew point during air conditioning use. To prevent condensation from forming on the drain line traps and dripping onto the ceiling below, these condensate drain lines should be insulated. This is also an item that can be simply addressed during routine maintenance.

Consult an HVAC specialist to assess and service these air conditioning systems.
