Home Inspection Report
for
John Smith

The Villages at Manu Kai
Kilauea Coast HI 96731
TMK #3-6-0-0-0

Home inspection Summary Report for:
John Smith

Location:
The Villages at Mauna Lani
Kohala Coast HI 96743

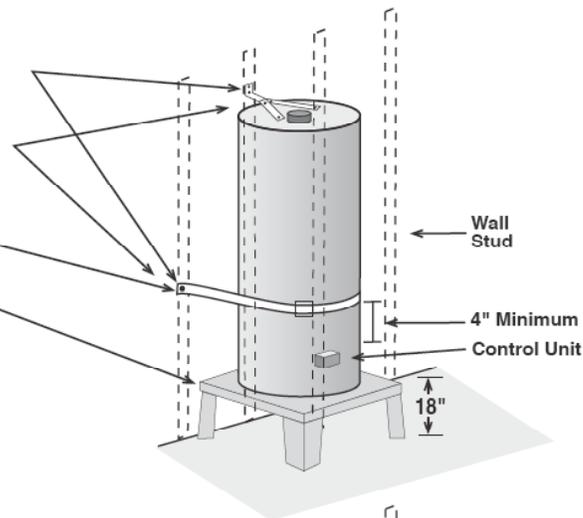
The lower strap must be a minimum of 4" above the control unit.

This 18" stand is required for heaters installed in a garage location.

I would recommend adding an additional seismic safety strap to the lower 1/3 of the water heater per the Uniform Plumbing Code (UPC), section 510.5 "In seismic zones 3 and 4, water heaters shall be anchored or strapped to resist horizontal displacement due to earthquake motion. Strapping shall be at points within the upper one-third (1/3) and lower one-third (1/3) of its vertical dimensions. At the lower point, a minimum of four (4) inches (102mm) shall be maintained above the controls with the strapping."

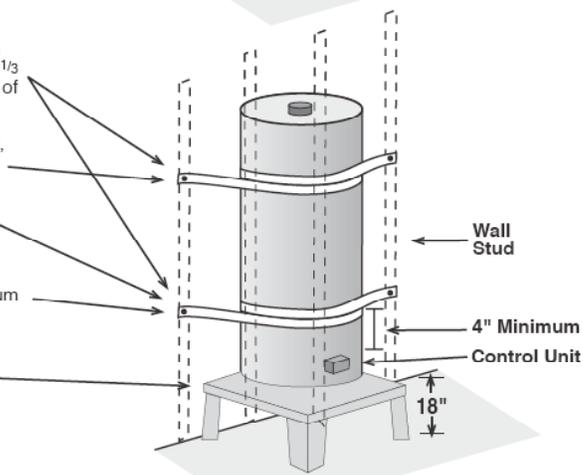
Example 2

Minimum 22 Gauge metal strap material installed within the top 1/3 of the heater and the bottom 1/3 of the heater.

The lower strap must be a minimum of 4" above the control unit.

This 18" stand is required for heaters installed in a garage location.
